TECHNICAL ADVICE

# PREPARATION

## Efflorescence in Masonry

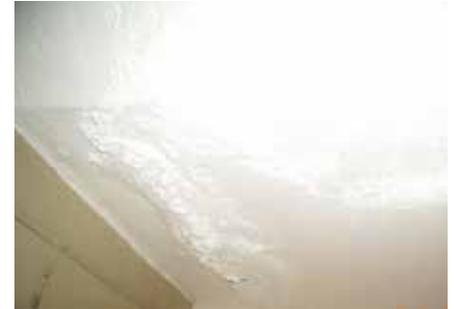
Paint systems adhering normally to the surface of the substrate can also be forced off (delaminate), when the pressure caused by the growth of salt crystals builds up beneath the paint film, resulting in its gradual but irreversible destruction.

Since the mineral salt crystals are not fluid, the pressure is therefore not uniform hence the coating does not form smooth rounded blisters. The paint film may stretch to form the outline of the growing crystals or the paint film may just rupture, crack, flake or peel instead.
